KIMBALL (L ROBERT) AND ASSOCIATES EBENSBURG PA
NATIONAL DAM INSPECTION REPORT. LAKE ONDAGA DAM (NDI ID NUMBER --ETC(U)
APR 81 R J KIMBALL

PENNSYLVANIA
LAKE ONDAWA DAM

NDI ID NO. PA-517

6 National Dam Inspection Report

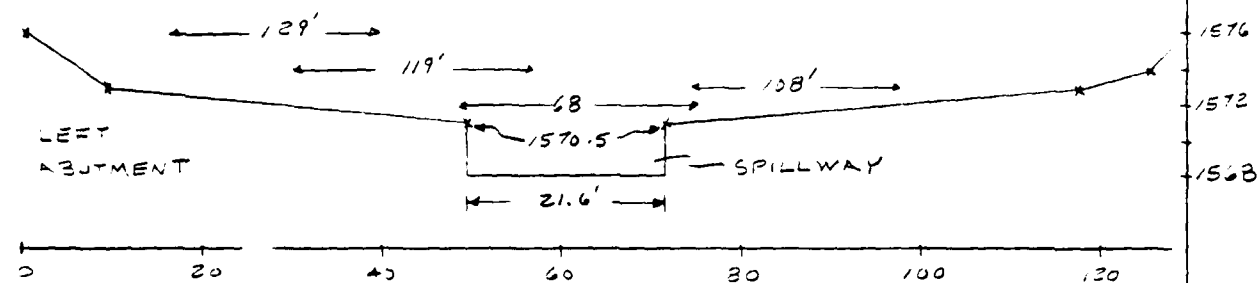
TOP OF DAM PROFILE
VIEWING DOWNSTREAM

THE PMF ANALYSIS INDICATES THE DAM IS OVERTOPPED BY 3.45 FEET DURING THE 1/2 PMF. THE DEPTH OF OVERTOPPING AND DURATION IS CONSIDERED SUFFICIENT TO CAUSE FAILURE OF THE STRUCTURE.
